**Ecological Site
Assessment Checklist**

Checklist for Ecological Assessment/Sampling

1. Site Name: Benning Road Facility
Location: 3400 Benning Road, NE
Washington, DC 20019
County: _____ City: _____ State: _____
2. Latitude: 38 degrees 53'54.97" N Longitude: 76 degrees 57'43.23" W

Benning Road Facility RI/FS Project
3400 Benning Rd., NE
Washington, DC 20019

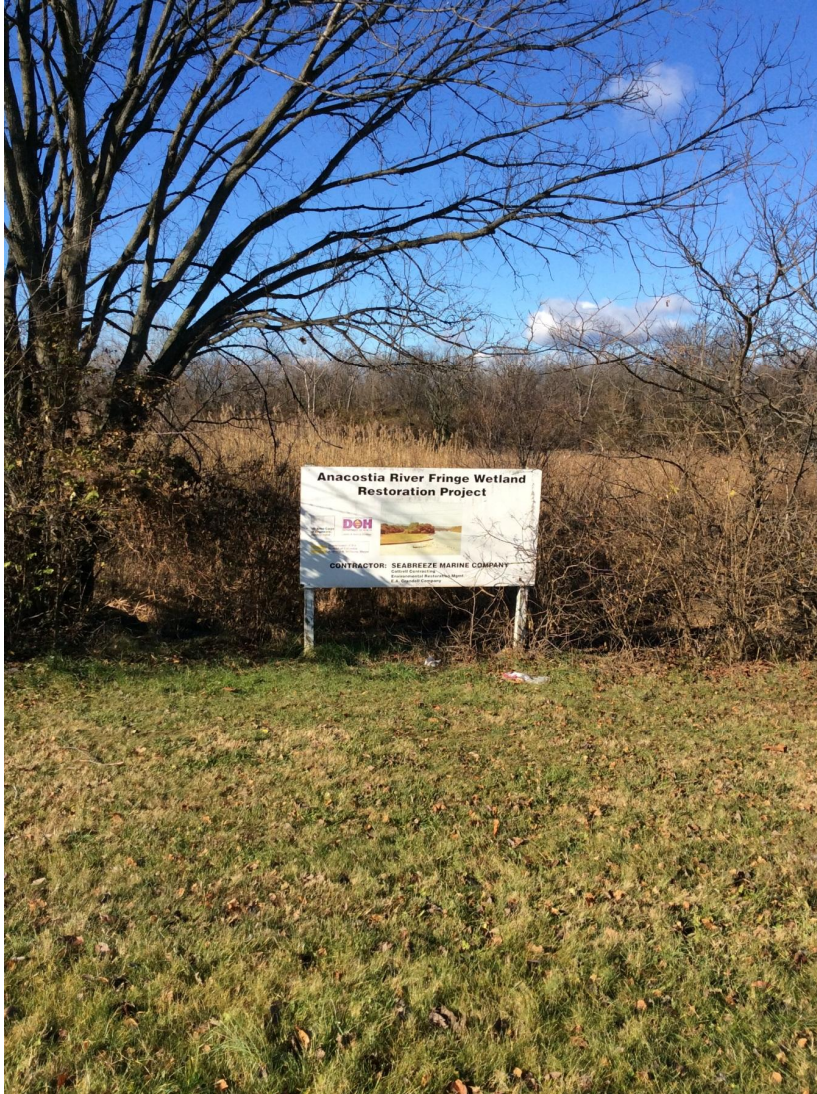
Photo 1. The Anacostia River Fringe Wetland Restoration sign on the Anacostia Riverwalk Trail.

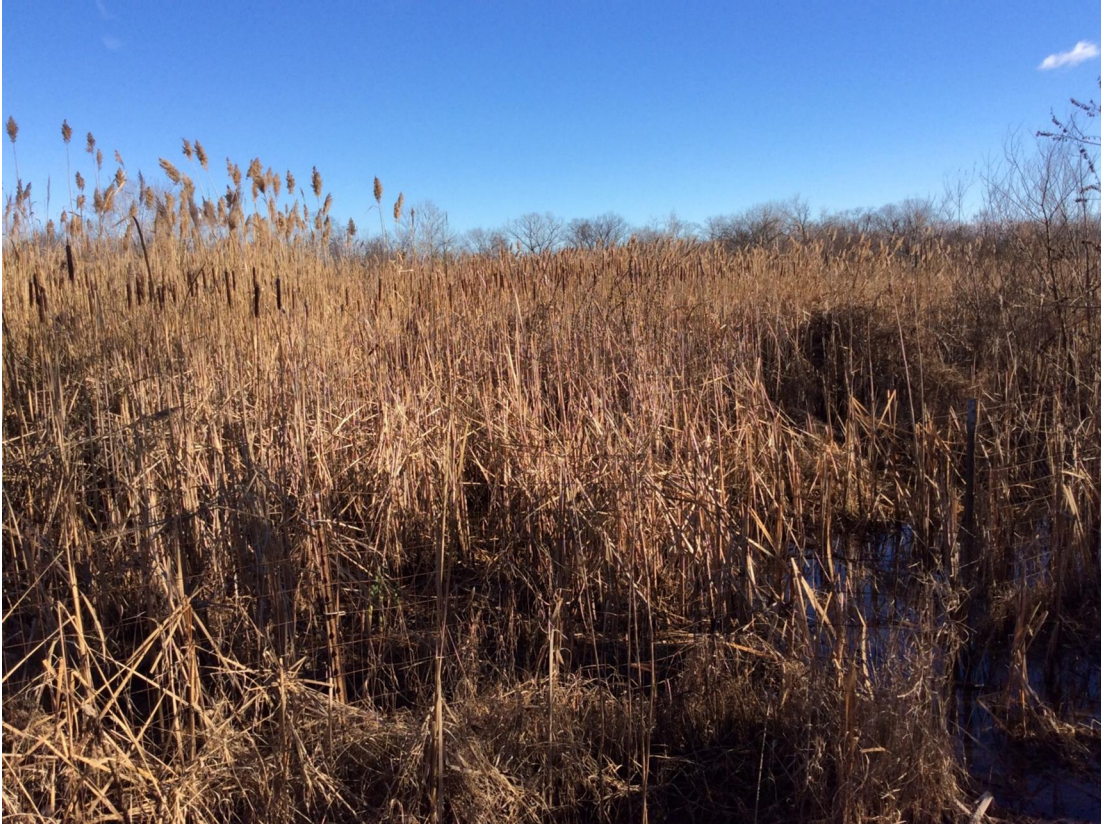
The dominant species of emergent wetland vegetation present are *Phragmites australis* and *Typha* sp.

Photo 2. Emergent wetland vegetation in the restored Fringe wetland on the eastern shoreline.

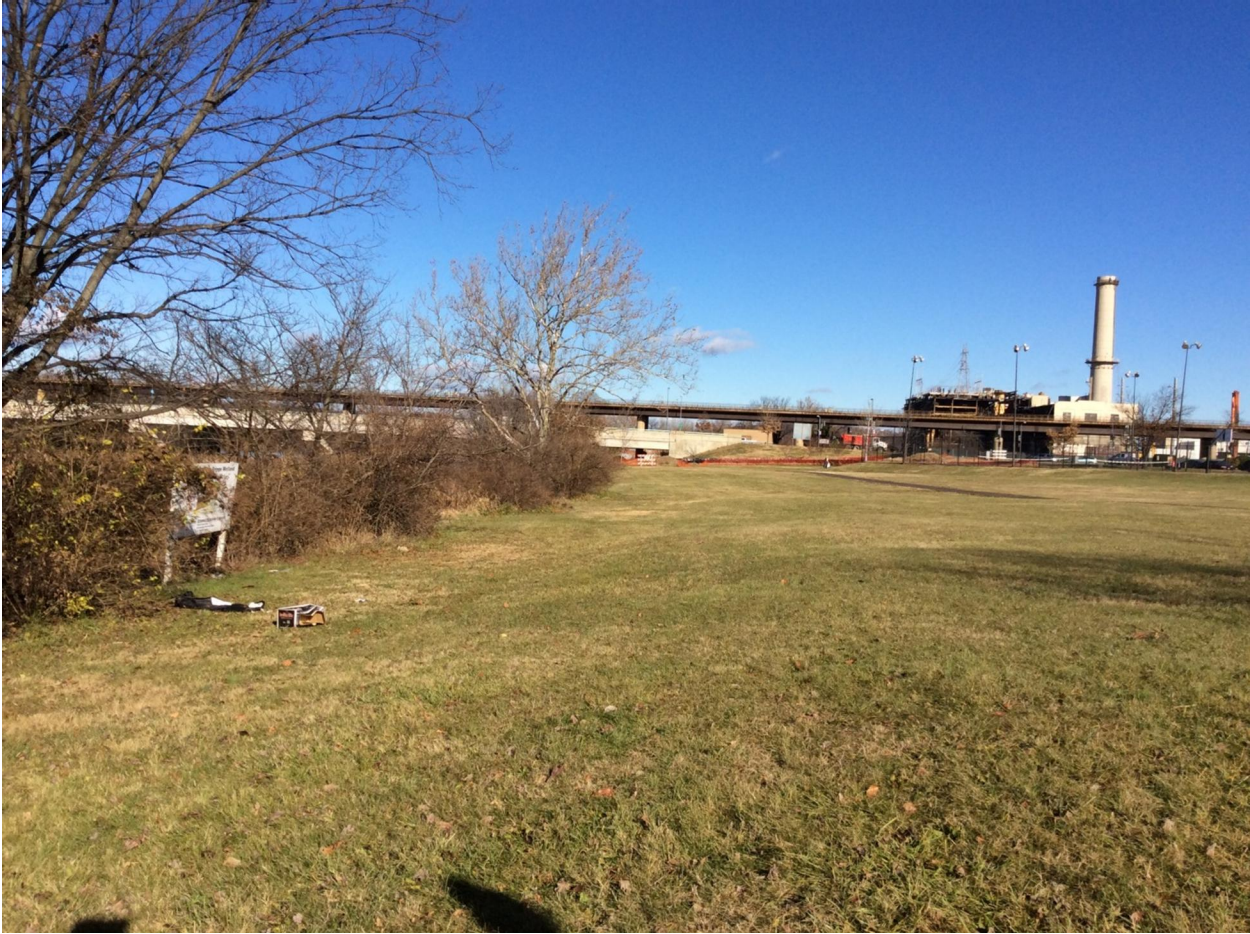
Photo 3. The shoreline along the Anacostia Riverwalk Trail.

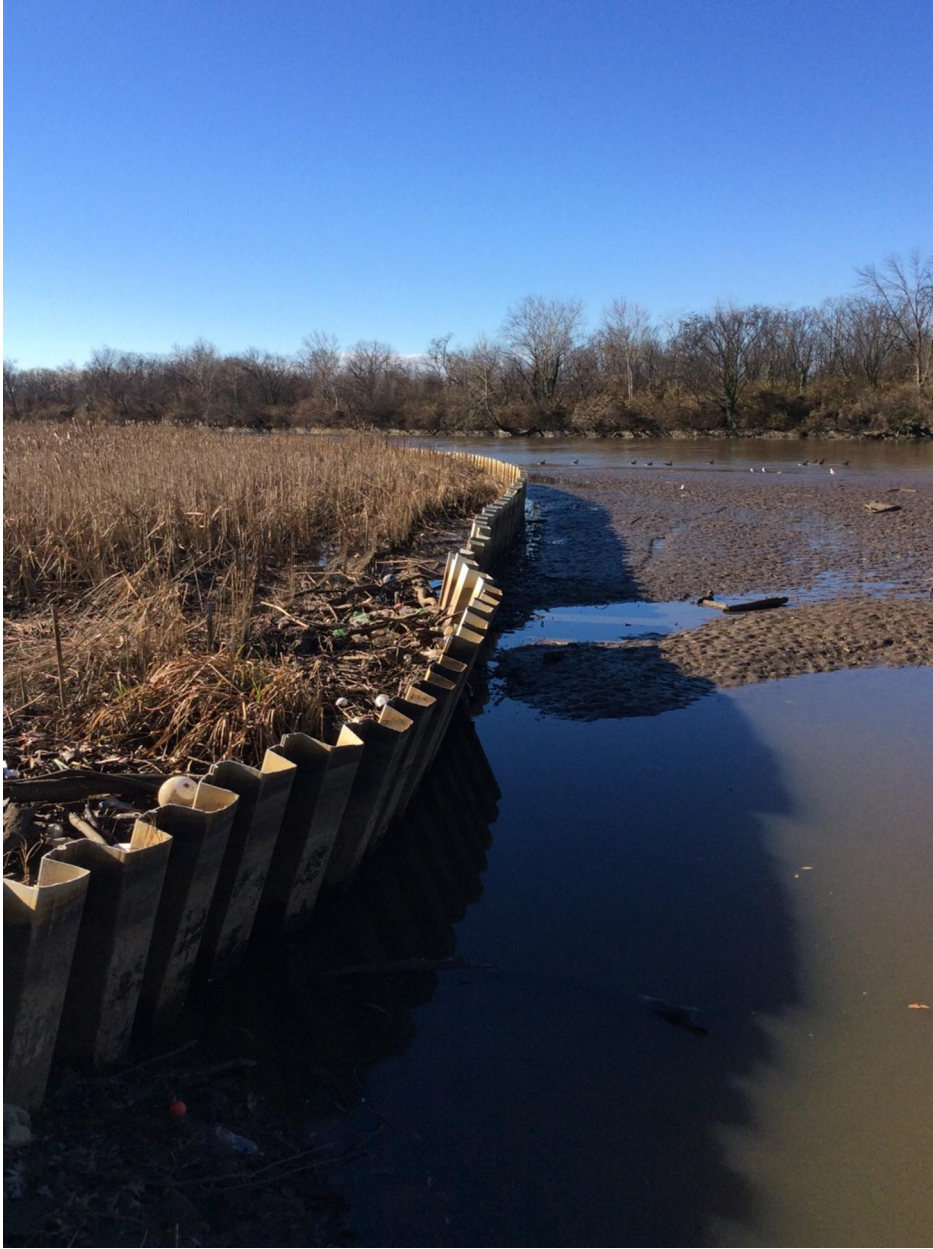
Most of the eastern shoreline were stabilized with either sheet pile or rockwall. Riparian vegetation consisted of large trees and shrubs, which occurred dense in some areas and sparse in other areas. Tree species included maple, oak, and sycamore. The bank slope ranged from gradual to shallow slope to the river edge. The western shoreline was observed to be uniformly stabilized with a continuous rock wall with dense tree cover throughout. The bank appeared steeply sloped in some areas.

Photo 4. Sheet pile surrounding the Fringe wetland on the eastern shoreline.

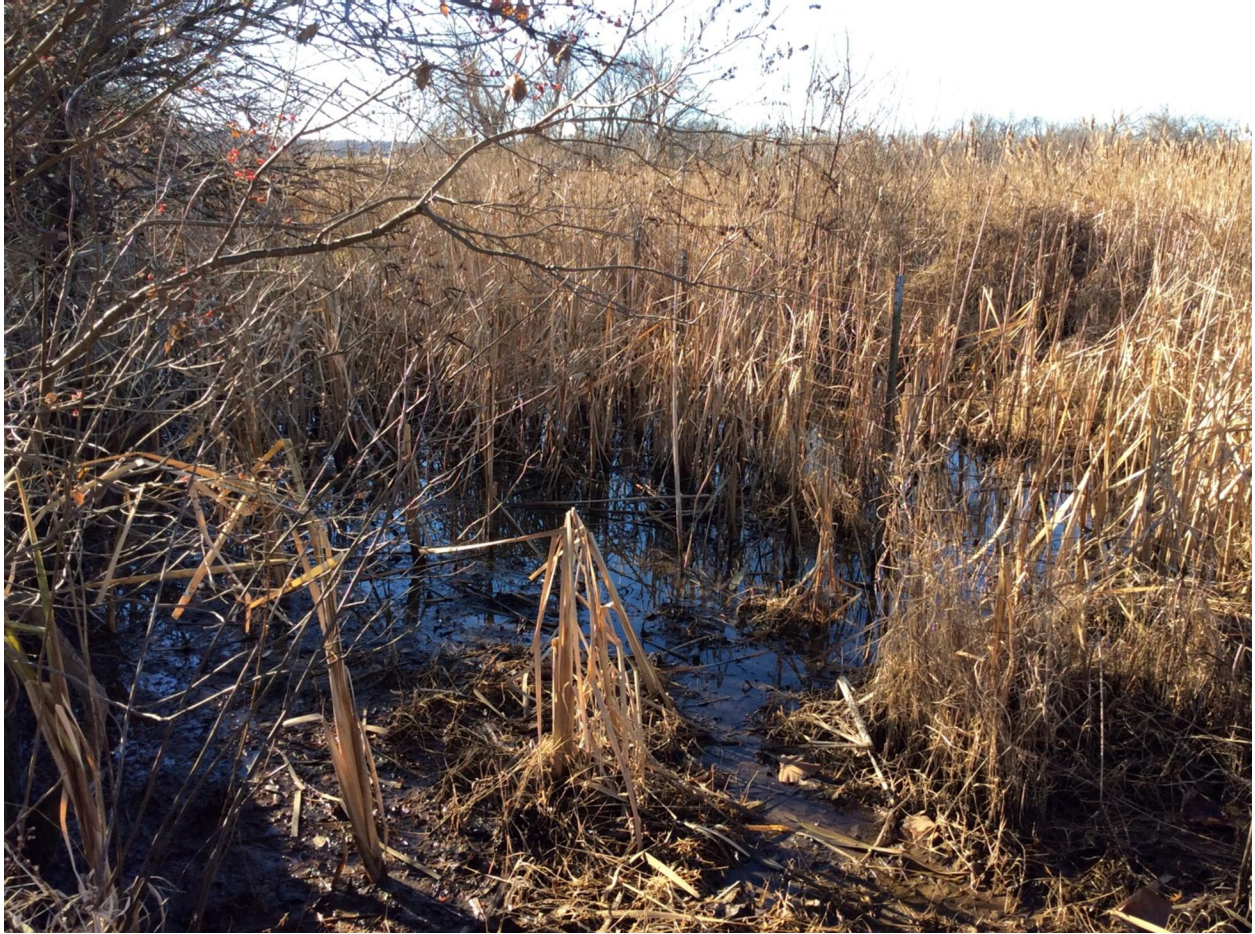
The surface water of the Anacostia River appeared blue-brown and slightly turbid in areas. Some standing water within the wetland areas was observed, likely stranded during the low tide, and appeared to be brownish with a metallic sheen on the top in some areas.

Standing water was observed near the shoreline within the emergent wetlands and is likely river water that is stranded at low tide. The area of standing water varied with location and likely varies with tidal height. The area of standing water observed for this assessment ranged from 10 to 25 square feet. It was noted that the water would not be standing in these areas during high tide. Therefore, these areas are not considered to be true non-flowing systems.

Photo 5. Standing water observed in the emergent wetland vegetation on eastern shoreline.

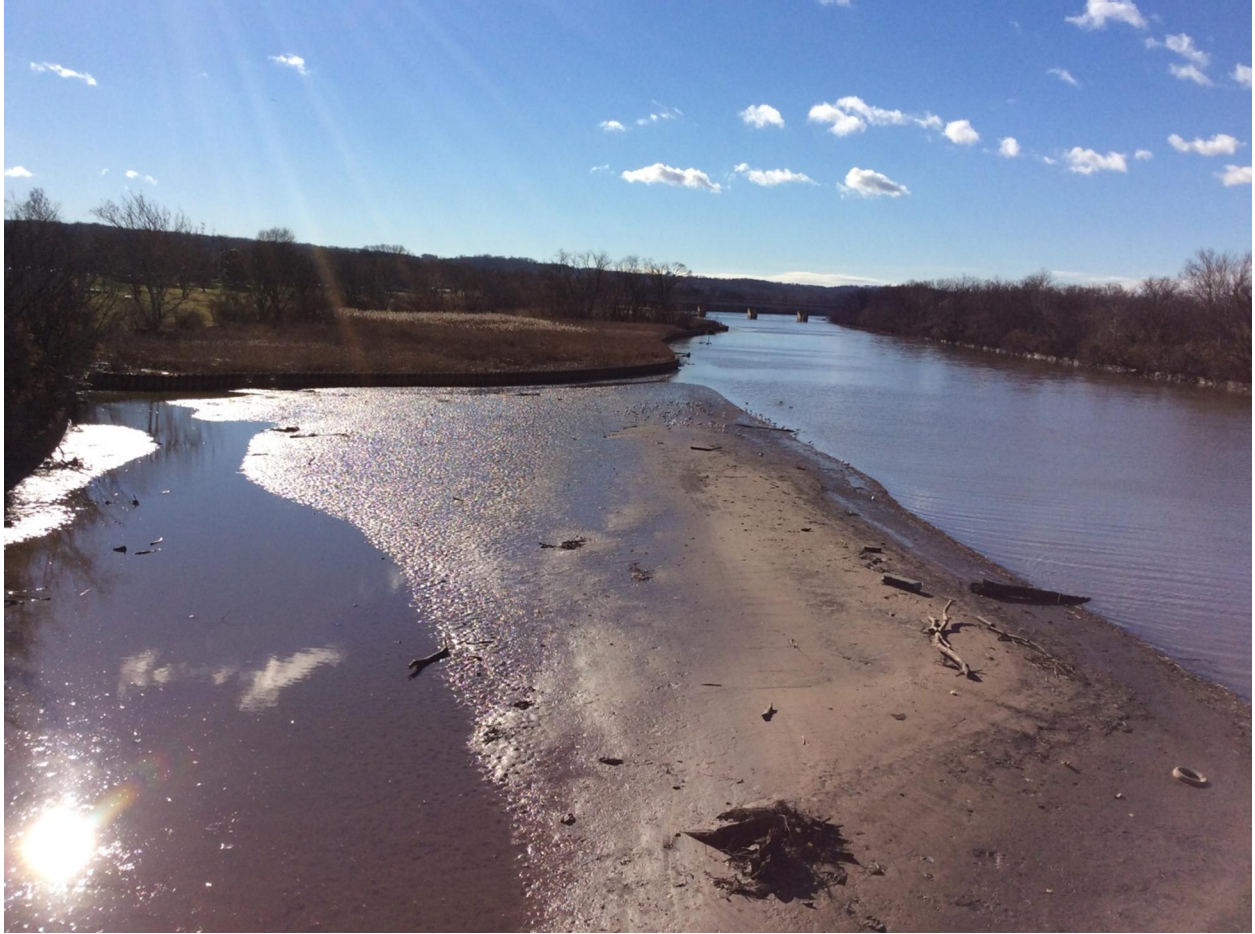
Photo 6. A view of the river from the Benning Bridge looking south (downstream). A large mudflat is in the foreground and the restored Fringe Wetland is in the background.

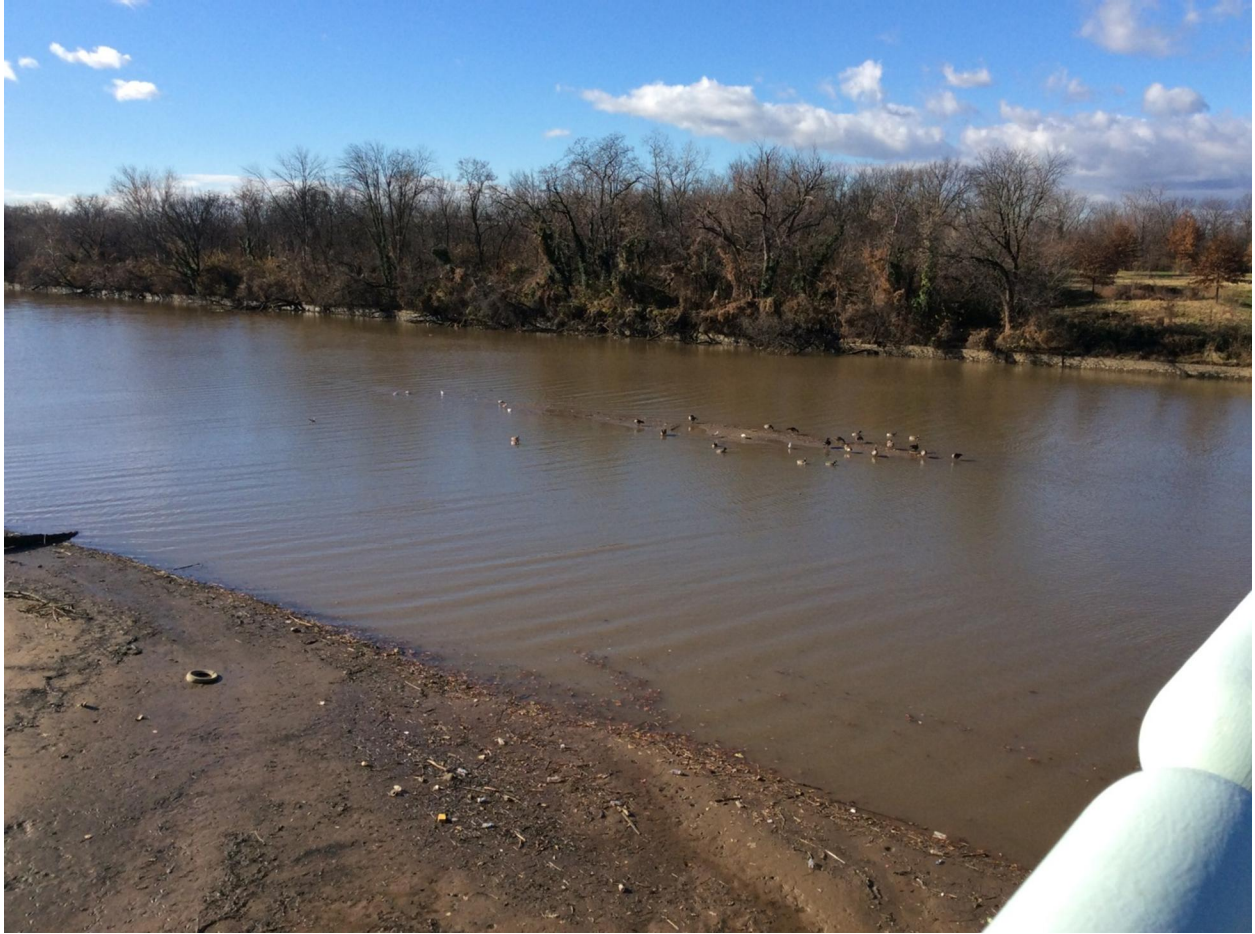
Several bird species were observed on the water and on mudflats in the river including:

- Mallards (*Anas platyrhynchos*)
- Species of gulls (*Laridae* family)
- Canada Geese (*Branta canadensis*)
- Belted kingfisher (*Megaceryle alcyon*)

Photo 7. Several aquatic birds were observed including gulls, ducks, and geese.

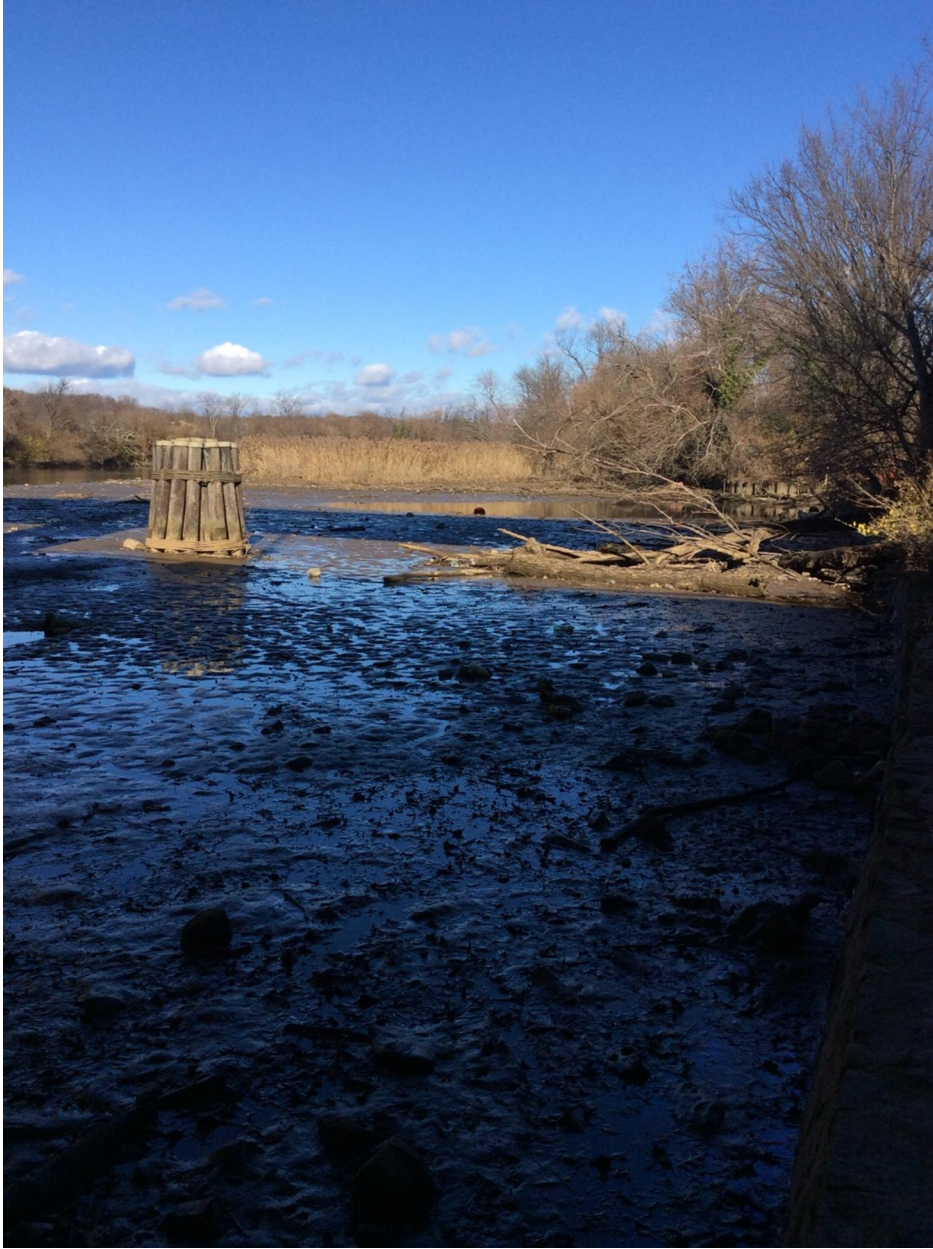
Photo 8. A large mudflat under the Benning Bridge, looking north (upstream).

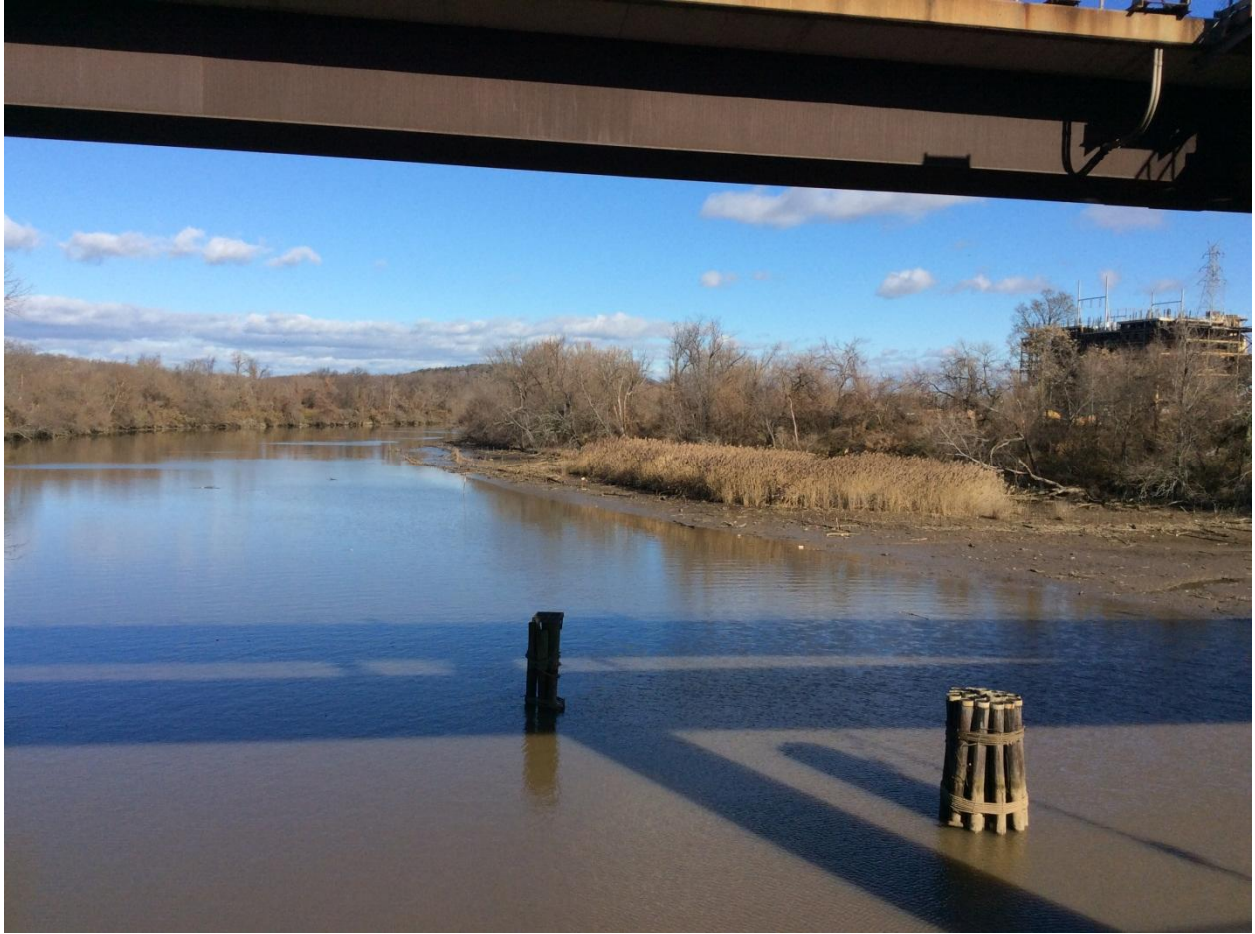
Photo 9. A smaller patch of restored Fringe Wetland on the eastern shoreline looking north from the Benning Bridge.

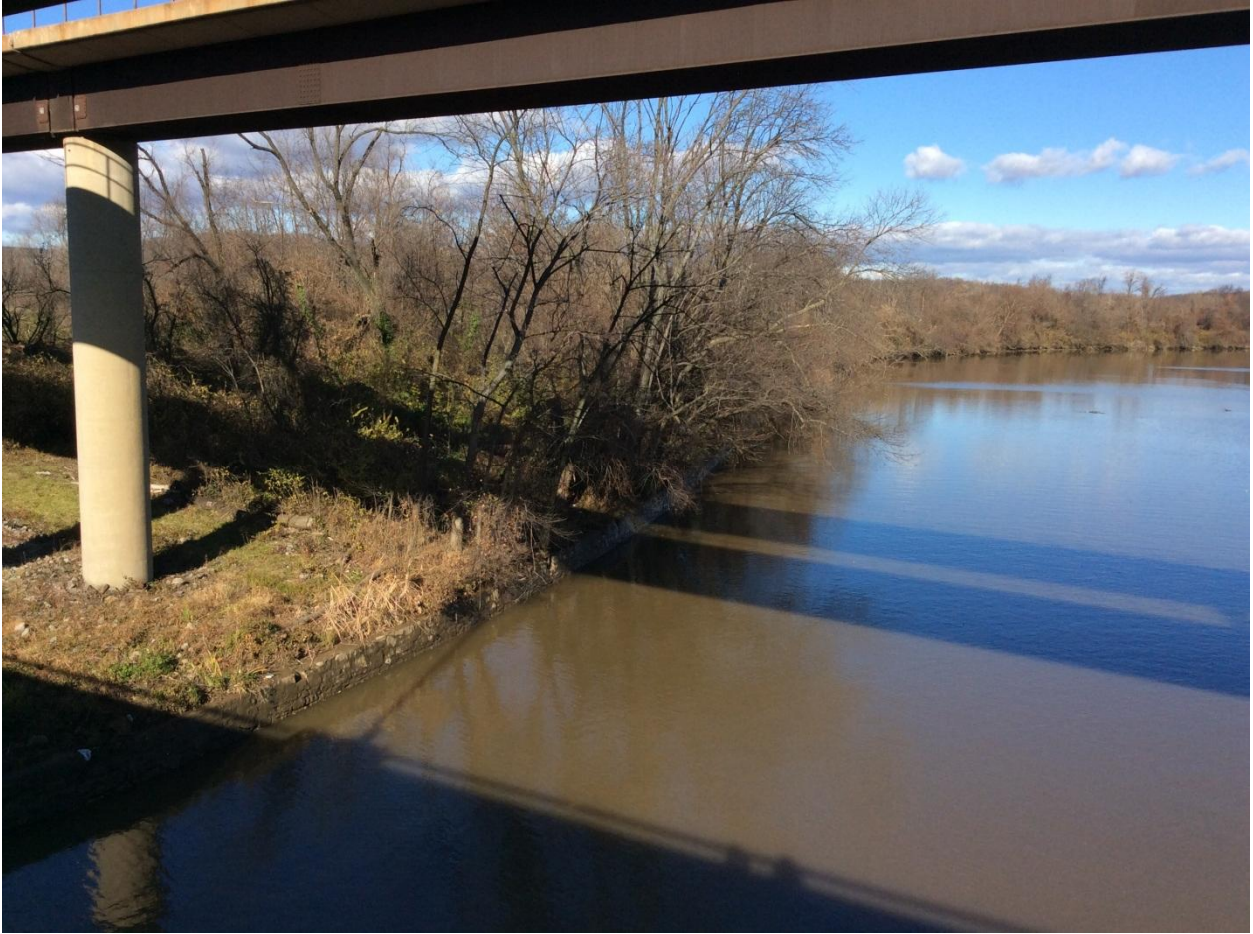
Photo 10. The steep western shoreline with dense tree cover viewed from the Benning Bridge.

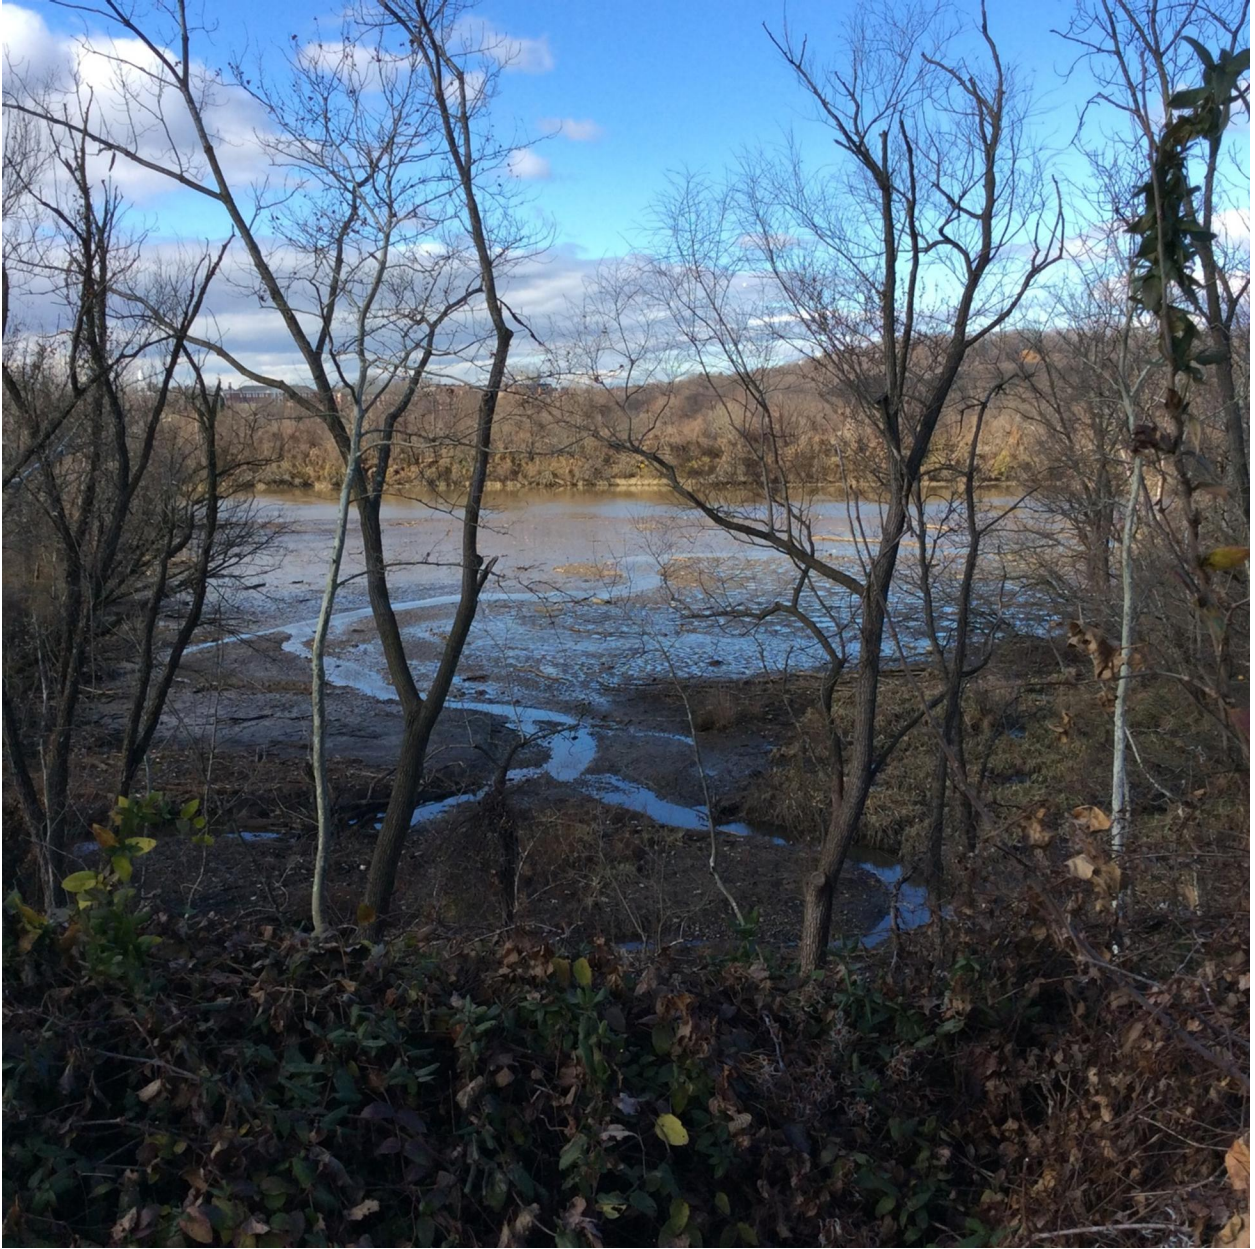
A view of the river near Outfall 013 was obtained from the Solid Waste Transfer Station. Mudflats were exposed in this area along the eastern shoreline and some small patches of *Phragmites*. The shoreline was gradual in slope with little bank stabilization. The western shoreline was densely forested with a more steep shoreline.

Photo 11. The mudflat at Outfall 013.
