**Subject: *Additional Data Collection at the Waterside Investigation Area Cove
Benning Road Facility, 3400 Benning Road, NE, Washington, DC***

Attachment A – Photolog

Attachment B – Figures

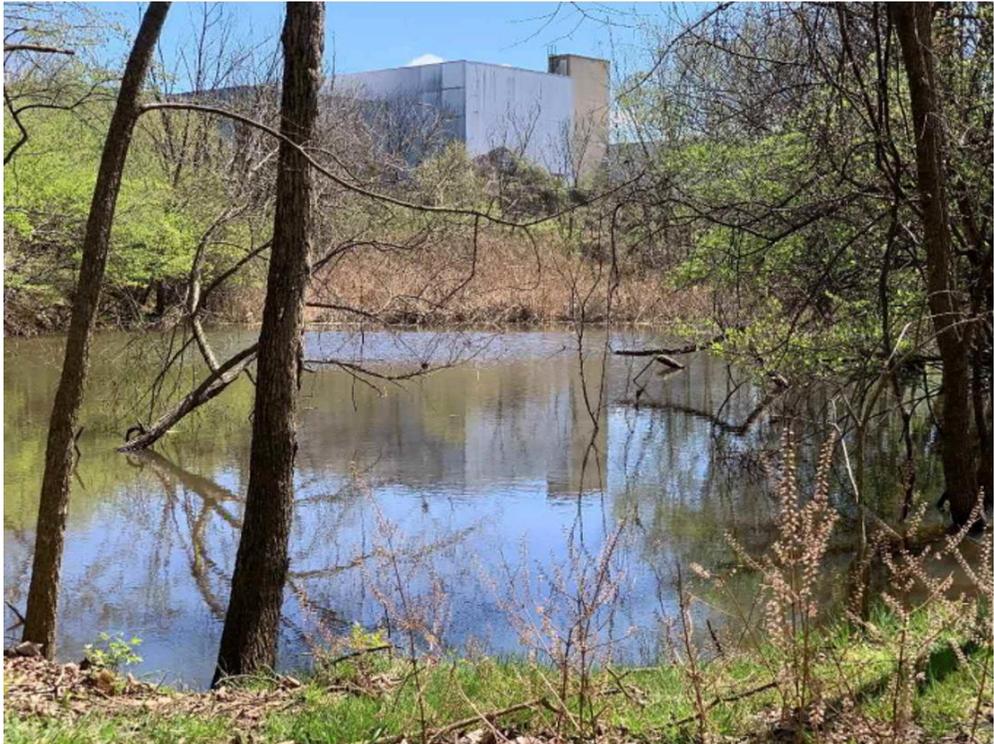
Photo No. 1	Date: 04/02/2021

Description: Silt pond in the southeastern portion of KPS.

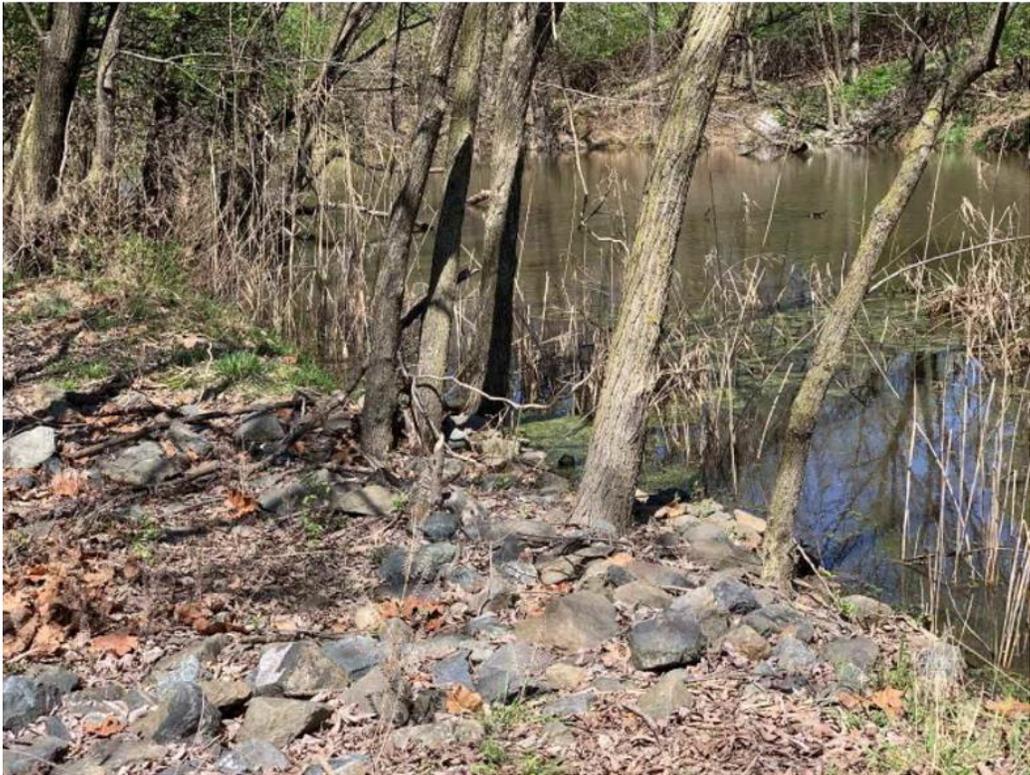
Photo No. 2	Date: 04/02/2021

Description: A riprap spillway was observed on the southwest side of the silt pond, which appears to be designed to be discharge to the north shore of the Cove.

Samples KPS SPSW-1 and KPS SPSW-2 were proposed to be collected along a riprap spillway structure observed on the southwest side of the pond. No other outlets were observed during Pepco’s dry-weather reconnaissance. In the event that other outlets are observed during field actives, additional soil/sediment

samples will be collected and analyzed for the parameters specified for the KPS Silt Pond Spillway samples in the table above. Sample locations along the riprap spillway structure, or other pond outlets identified, will be field determined based on evidence of surface water runoff (i.e. erosional features such as worn or lack of vegetation, scours, gullies, etc.).

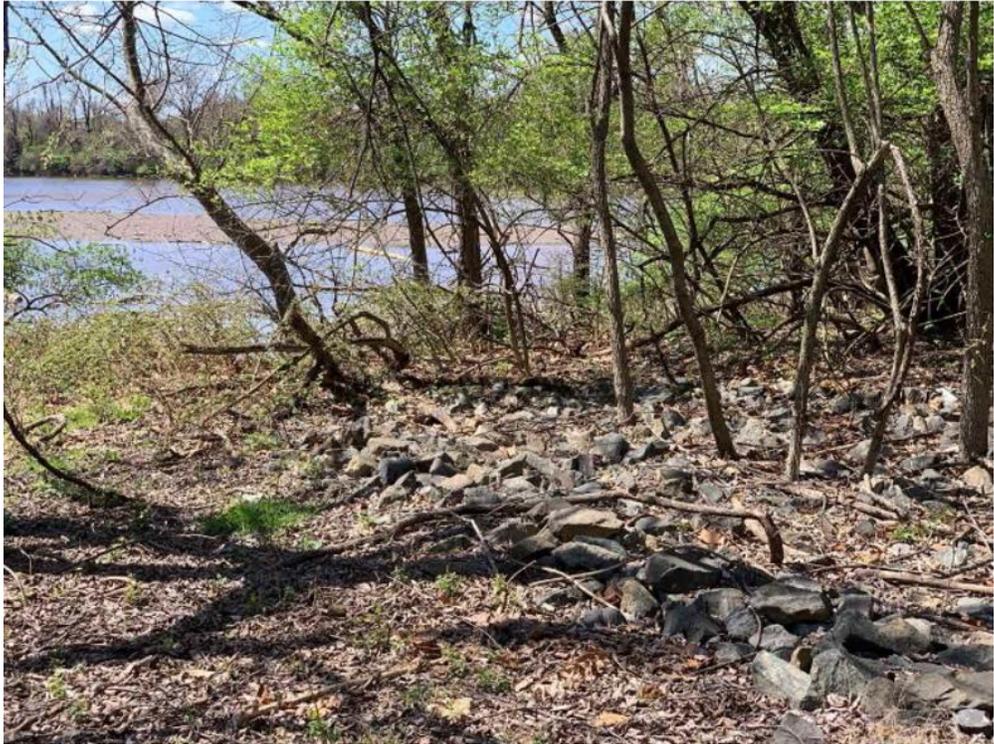
Photo No. 3	Date: 04/02/2021

Description: A riprap spillway was observed on the southwest side of the silt pond, which appears to be designed to be discharge to the north shore of the Cove.

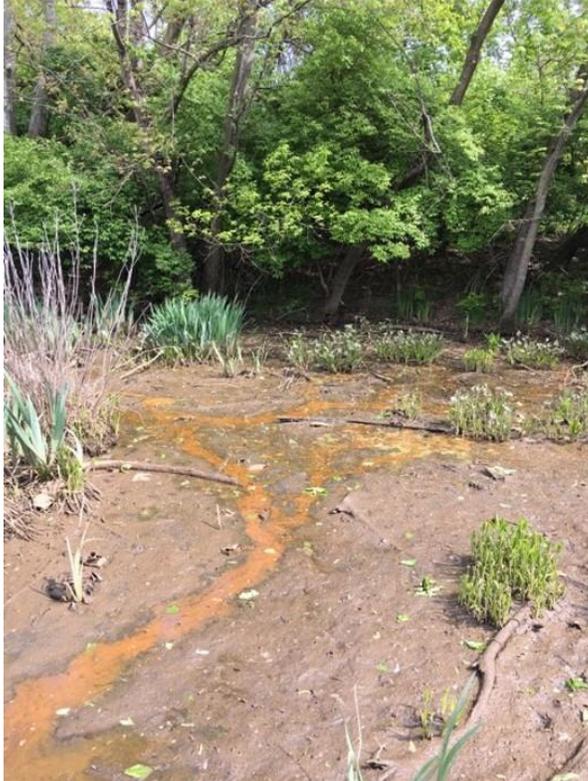
Photo No. 4	Date: 04/24/2020

Description: A potential seep with reddish brown tinge from KPS was observed to be flowing toward the channel in the Cove during low tide on April 24, 2021.

Although none of these seep samples were located along the northern face of the Cove, during low tide on April 24, 2021, AECOM noticed a potential seep with reddish brown tinge from KPS flowing toward the channel in the Cove. Pictures of this potential seep are provided in **Attachment A**. If conditions permit, Pepco proposes to collect a sample from this seep.

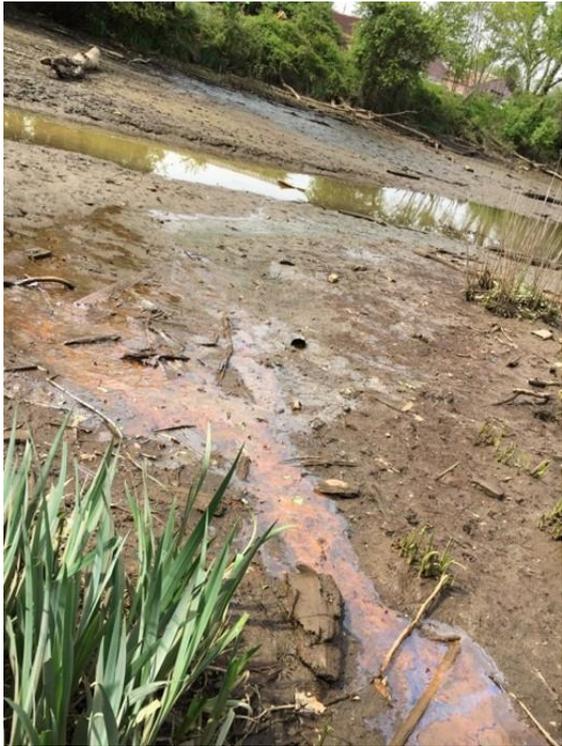
Photo No. 5	Date: 04/24/2021

Description: A potential seep with reddish brown tinge from KPS was observed to be flowing toward the channel in the Cove during low tide on April 24, 2021.

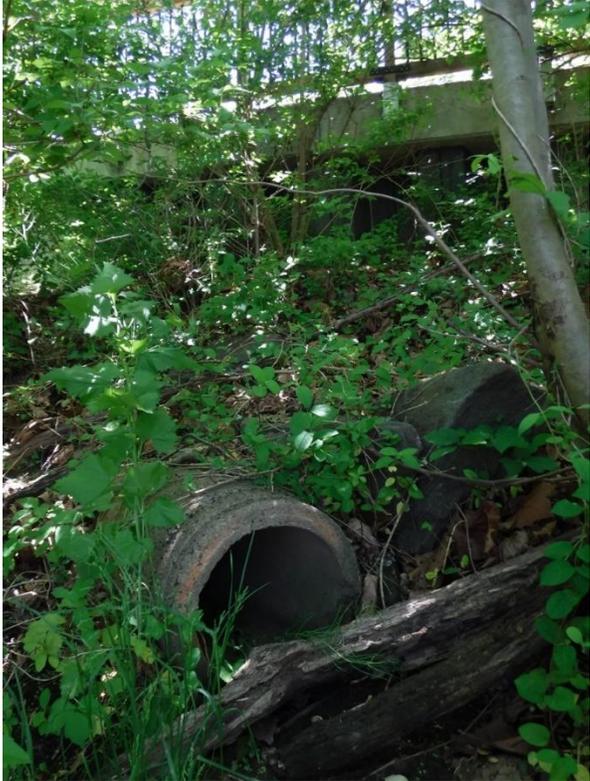
Photo No. 6	Date: 04/02/2021

Description: DPW Outfall 001 (Outfall 06 in Figure 1), one of the three outfalls associated with the waste transfer station property, was not identified until after the field sampling was completed.

One of the three outfalls associated with the waste transfer station property, Outfall 6 (DPW Outfall 001), was not identified until after the field sampling was completed. Additional sampling is proposed in this plan to assess potential impacts to the Cove from this outfall. In addition, it is our understanding that DOEE is planning a further investigation to confirm the sources of both wet and dry weather flow to Outfall 3 (DPW Outfall 003) and Outfall 4 (unknown origin) as well as the apparent interconnection of the drain pipes leading to these two outfalls.

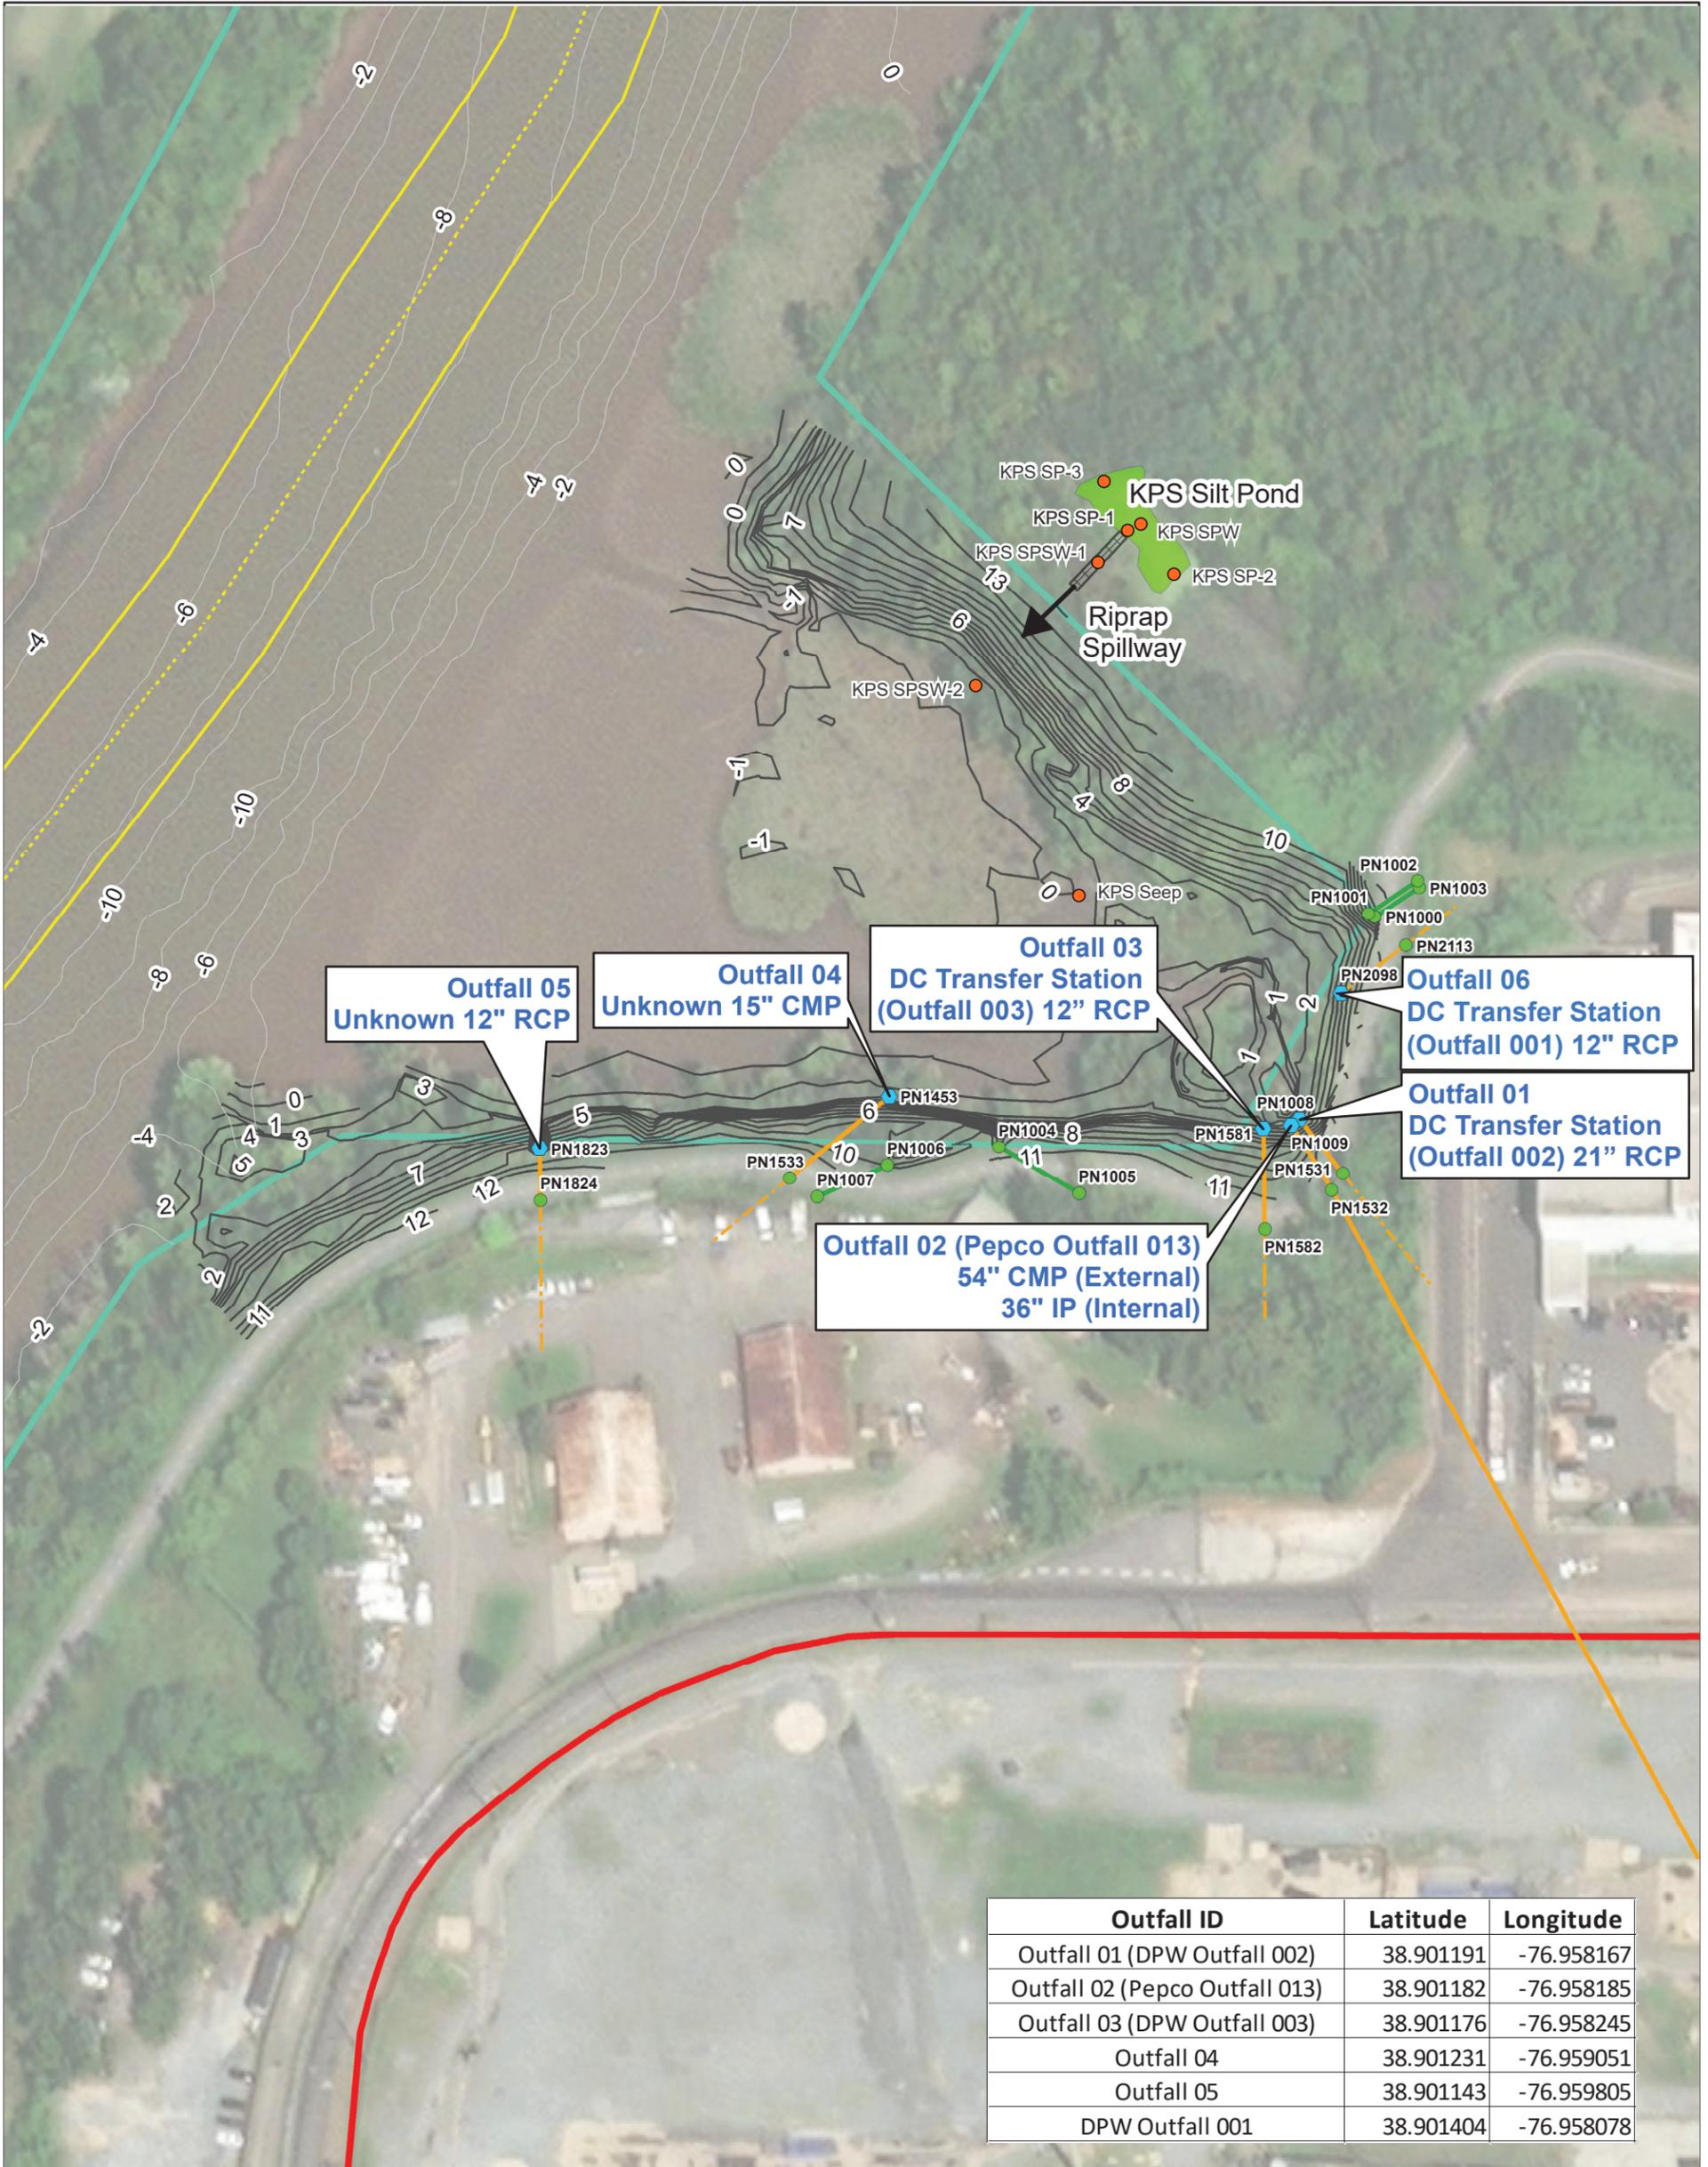
BENNING ROAD FACILITY RI/FS PROJECT 3400 BENNING RD., NE WASHINGTON, DC 20019			COVE OUTFALL LOCATIONS	
Date: 5/14/2021	Drawn By: DCB	Checked By: RD	FIGURE 1

The proposed sample locations are shown in Figures 1 and 2 of **Attachment B**. Sample locations/IDs, sampling intervals, proposed analysis, and location rationale are summarized in the table below:

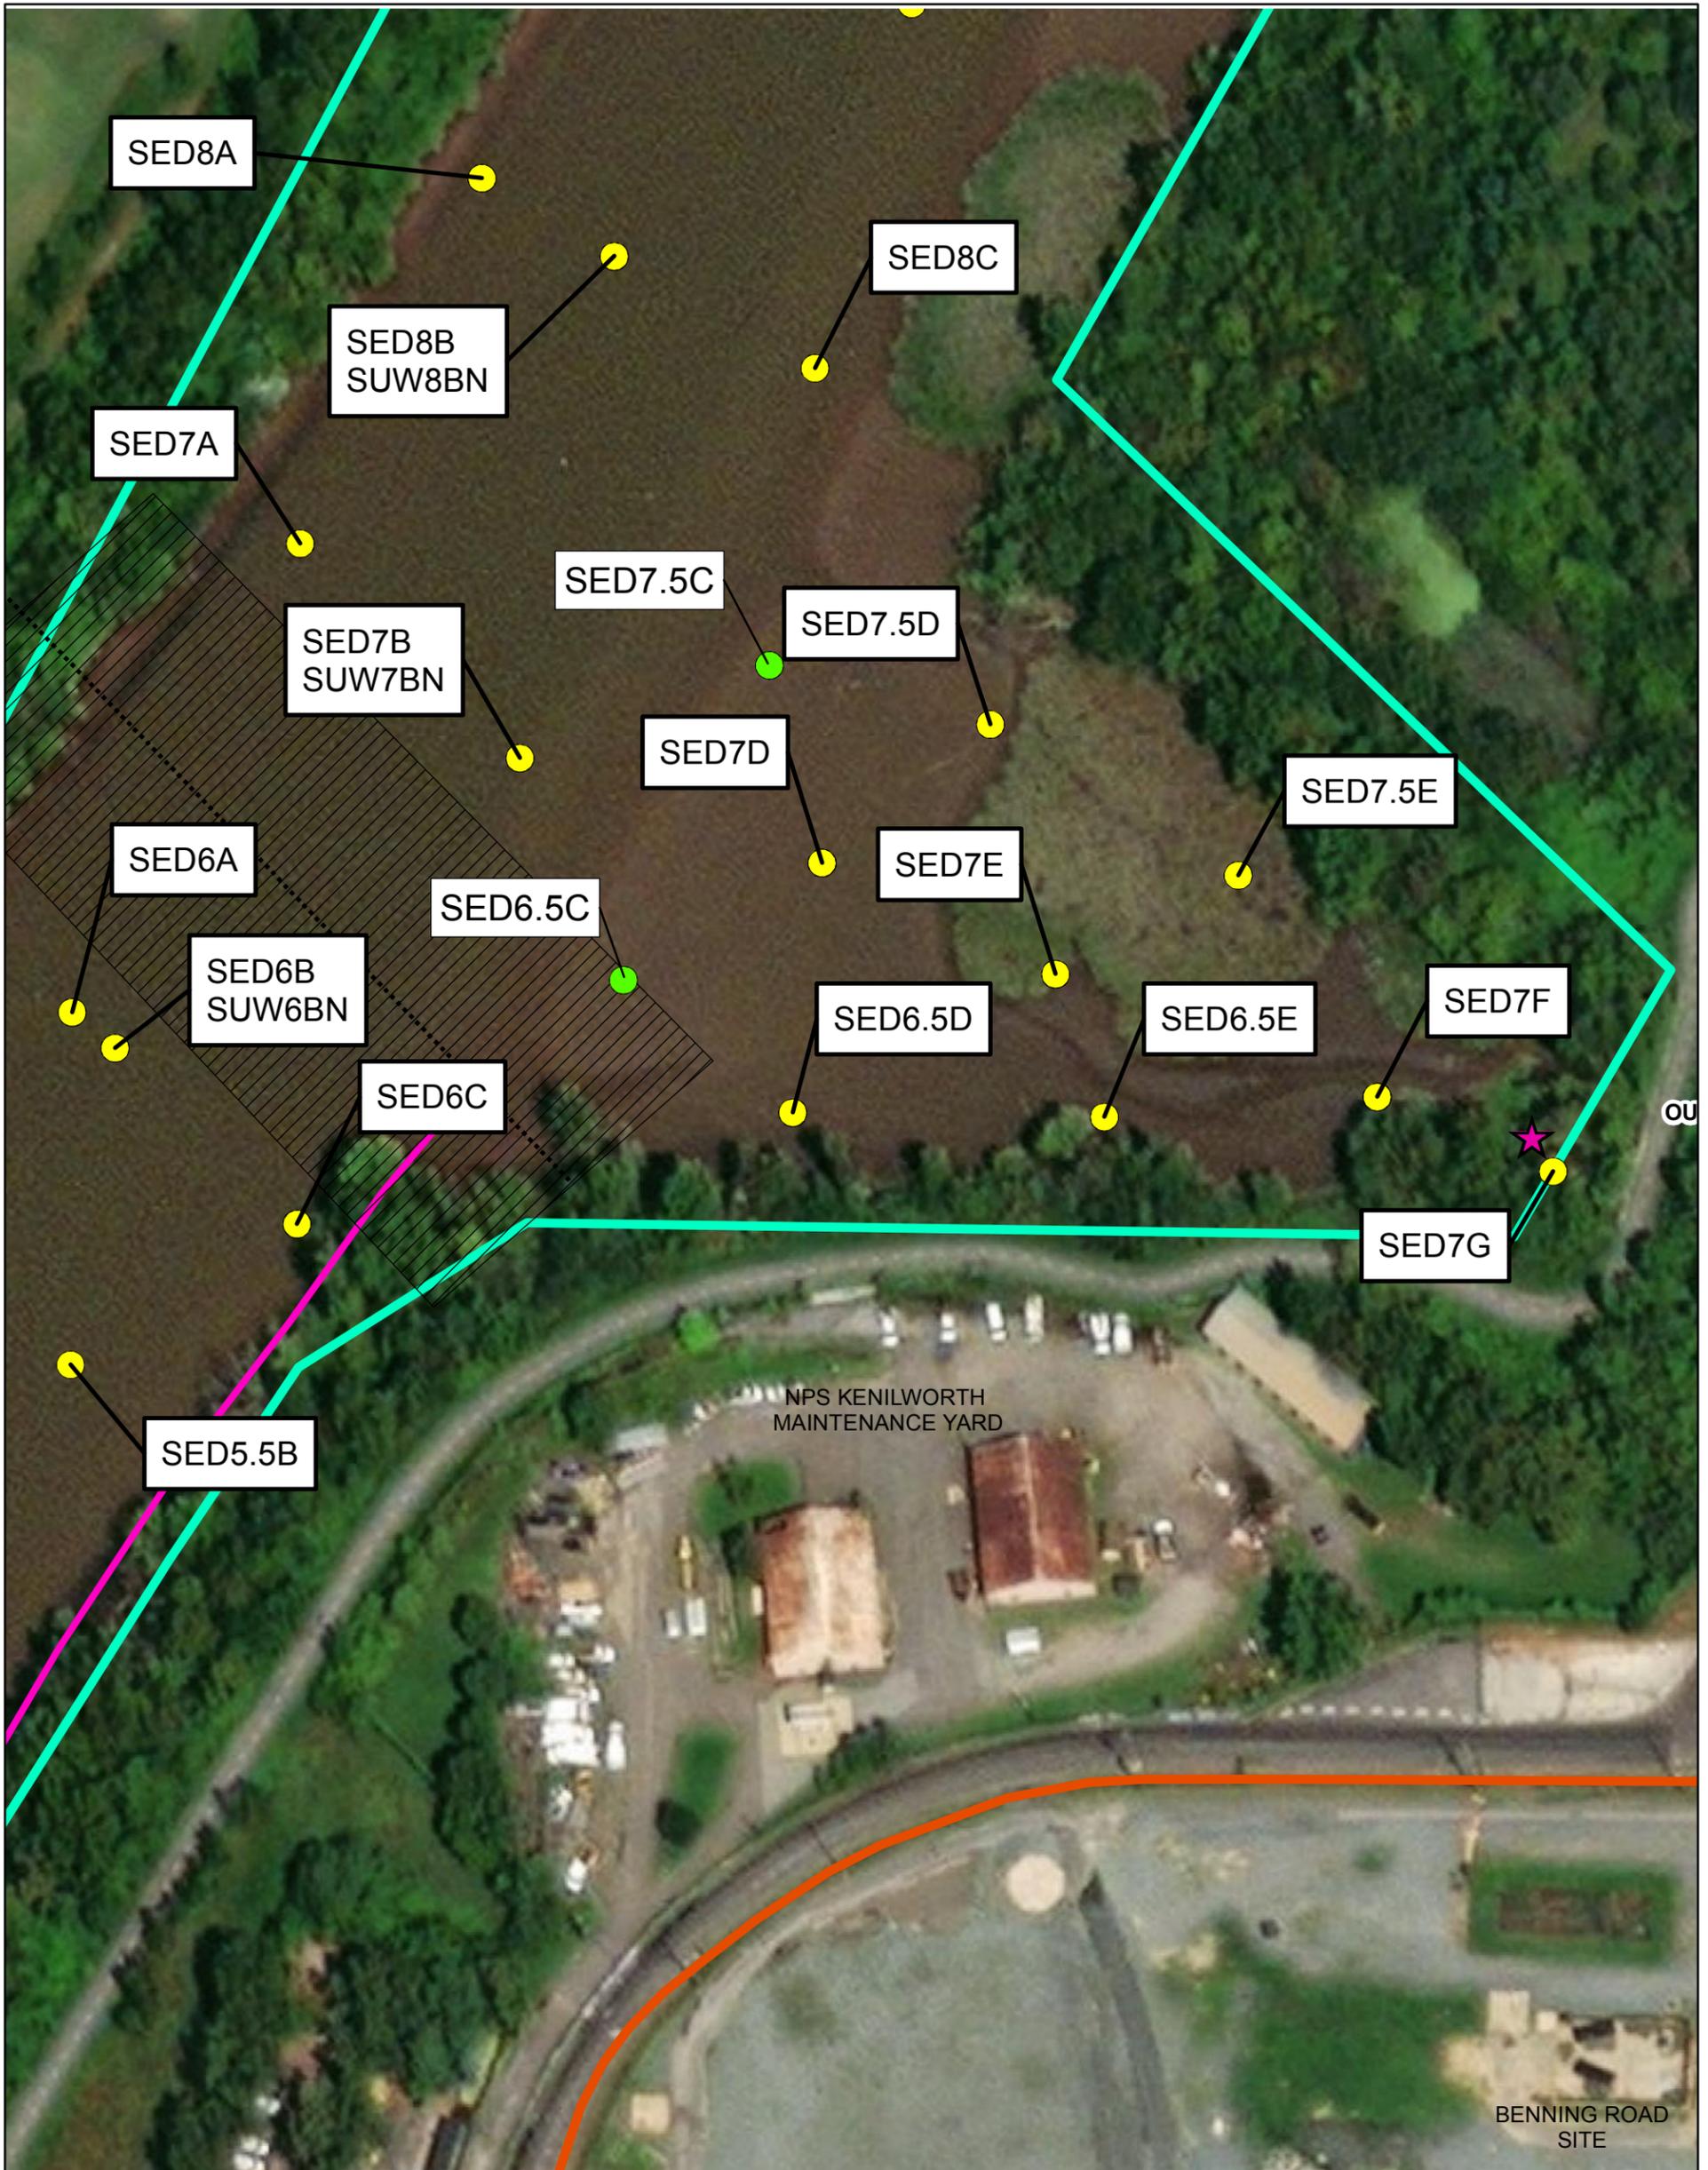
FIGURE 2

In addition, Pepco is proposing to collect two additional sediment samples, SED6.5C and SED7.5C, at the locations shown in Figure 2 of **Attachment B**. These samples would provide additional data at the

mouth of the Cove to the main stem of the Anacostia River. This additional data would help better understand the sediment profile in this transition zone.

ADDITIONAL SEDIMENT SAMPLES
 IN THE COVE
